Partial Discharges (PD) Acoustic Detection

Partial Discharges (PD) Acoustic Detection
(Hugo Resendiz, CMRP | CTRL Systems, Inc. | March 2020)

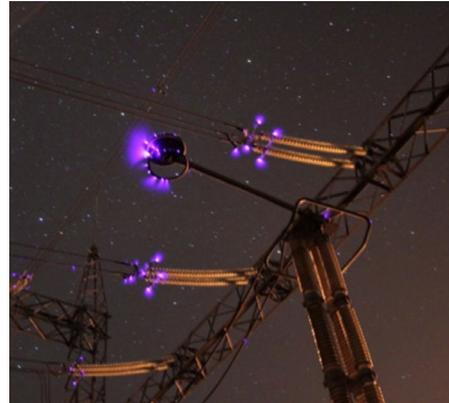
Corona is a changing zone of ionized gases, identifiable to the inspector through airborne ultrasound. Corona discharge occurs when the voltage in electrical conductors, such as an antenna or a high-voltage transmission line, exceeds the threshold value. The air around the high transmission line begins to ionize to form a blue or purple glow, generally visible in total darkness and with high humidity in the environment.

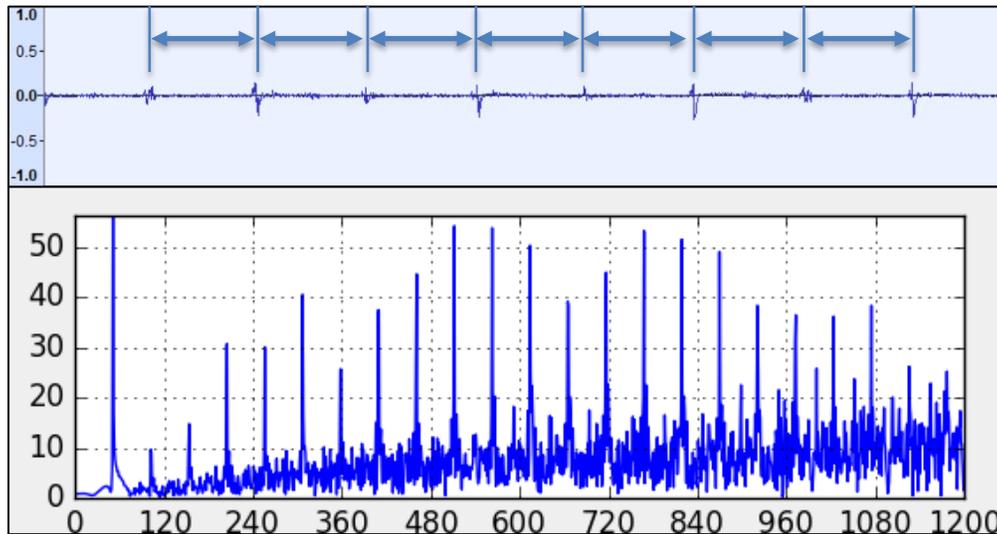
Fig. 1: Ultrasonic signature of Corona Discharge.

The ultrasonic signature of the Corona Effect is very characteristic, this is a buzz type background sound, with blows on it that are equivalent to the individual discharges, these blows as seen in the waveform graph at the top of figure 1, They are very constant in time series and are on the same frequency as electric power, 50 Hz or 60 Hz depending on the country where they are taken. By having broad redundancy of the discharges, they generate a spectrum full of harmonics, shown in the frequency spectrum (FFT) of figure 1.

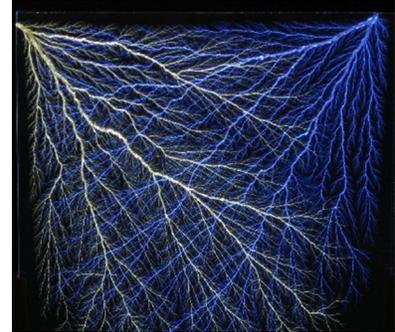
Tracking creates a carbonized current leak path in the form of lightning-like fractals, these over the dielectric that lost its capacity and are prematurely damaged by the discharge. This form is also known as Lichtenberg Figures in honor of the German physicist, Georg Christoph Lichtenberg. This tree structure is associated with the progressive deterioration of components and equipment under voltage, which the higher the voltage, the more problematic and risky a possible event is.

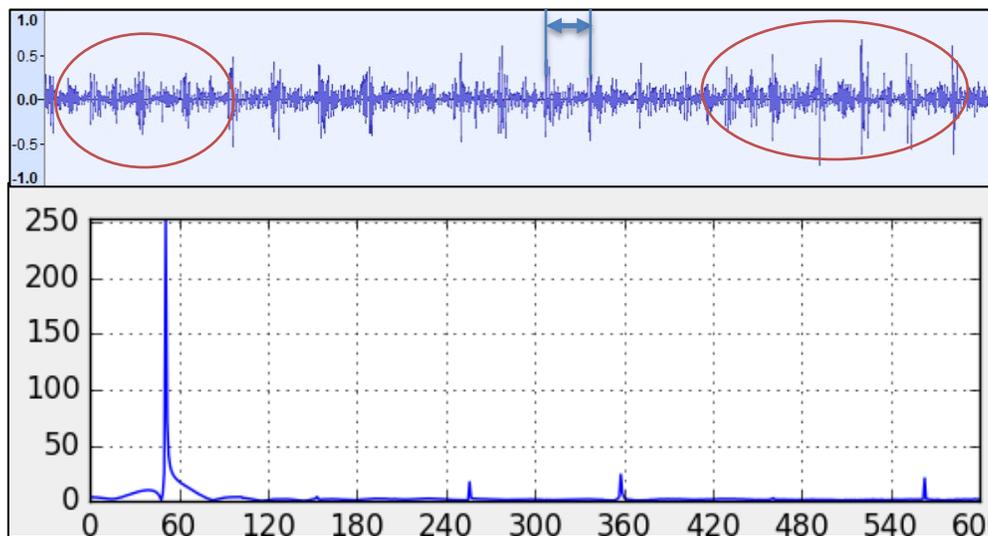
Fig. 2: Ultrasonic signature of the Tracking Discharge.

The monitoring pattern is erratic as seen in figure 2, since the discharges occur irregularly in the waveform of the electric current, that is, each shock of discharge has a component in the frequency of the electrical energy, however, it is very active as can be seen in the red circles. This can be seen in the decrease in harmonic peaks in the frequency spectrum (FFT), where there are peaks in 50 Hz or 60 Hz (depending on the electrical frequency of each country), but these are hidden since the behavior of the signal is irregular.

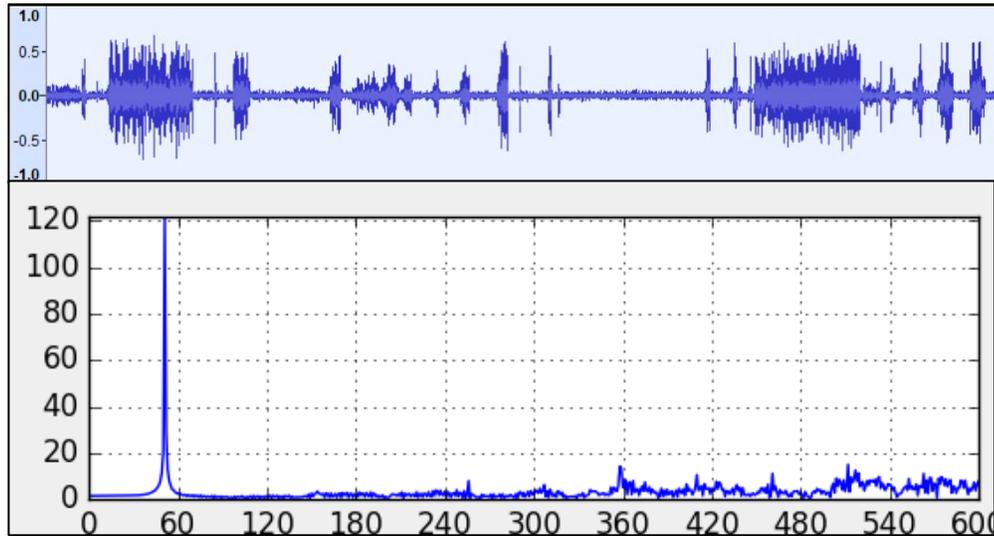
Fig. 3: Ultrasonic signature of the Electric Arc Discharge.

In figure 3 we can see the great difference between small discharges against energy blocks that are equivalent to the discharge of the electric arc, when we find an electric arc we are facing a security risk and an imminent failure, immediately action must be taken to prevent further damage.

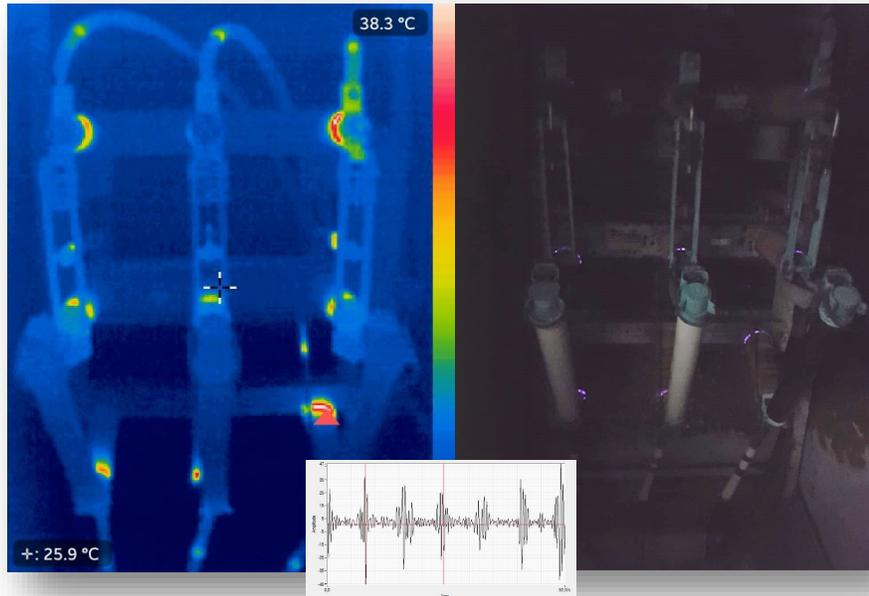
Fig. 4: Inspection of Medium Voltage Cell by Acoustic Ultrasound and IR Camera.

The separate ultrasound helps plant personnel to follow the protocol for opening cabinets and closed electrical panels, since they can listen behind a door to any abnormal situation that can help us make decisions that affect the safety of inspectors, such as not opening a door with a potential problem behind it. In figure 4 we can see that an anomaly was detected with ultrasound without the need to open the cell door. To see it with thermography, an IR peephole or fireproof suit should be used.
